W3150A+/W5100 Errata Sheet

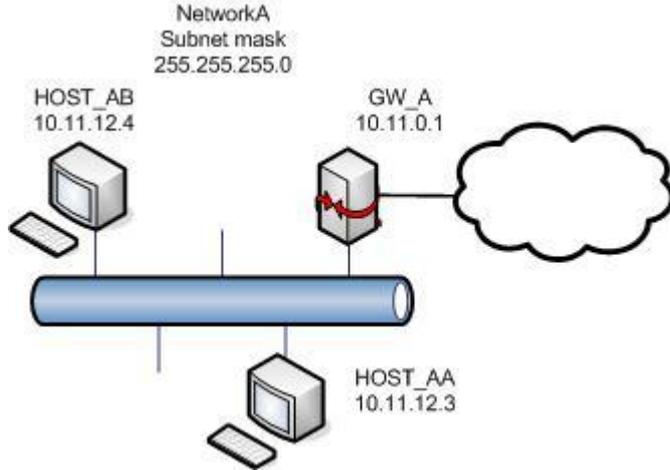
Erratum 1	
Phenomenon	<p>Unable to complete SEND/SENDMAC command in UDP/IP-Raw mode. That is, do not assert SEND_OK interrupt and do not equal the values of Socket n Tx Read Pointer Register (Sn_TX_RD) and Socket n Tx Write Pointer Register (Sn_TX_WR).</p>
Condition	<p>Generally, the Sn_TX_RD value is equal to the Sn_TX_WR value and asserts SEND_OK interrupt when a transmission process was completed.</p> <p>But the case of errata which the Sn_TX_RD and Sn_TX_WR values are different and do not assert SEND_OK interrupt in UDP/IP-Raw mode. This phenomenon is occurred when our chip receive data in opened socket (i.e. assert RECV interrupt) and simultaneously the application program (Host MCU) executes SEND/SENDMAC command on that socket.</p> <div style="text-align: center;">

<p>The diagram illustrates a network topology. At the top, 'NetworkA' is defined with a 'Subnet mask 255.255.255.0'. Below this, three devices are connected to a central horizontal bus: 'HOST_AB' with IP 10.11.12.4, 'GW_A' with IP 10.11.0.1, and 'HOST_AA' with IP 10.11.12.3. Each device is represented by a computer icon. A cloud icon is connected to the right side of the bus, representing an external network or internet.</p> </div> <p>Figure 1. General network</p> <p>In Figure 1 network,</p> <ol style="list-style-type: none"> 1. Open UDP socket in AA. Port number is 1000. 2. Send UDP data packet(destination port number 1000) from AB to AA. 3. AA processes the UDP data packet from AB. 4. Host MCU in AA runs SEND command to send. <p>When completion of 3 in AA (i.e. AA assert RECV interrupt), AA also runs 4 (i.e. run SEND command). In that case, do not complete process 4 due to errata.</p>

Solution	<p>In case of W3150A+,</p> <p>If you can monitor the RXDV signal (in MII interface), you can solve this problem.</p> <p>Before you execute SEND/SENDMAC command in UDP/IP-Raw mode, check the value of RXDV signal is '0'. That means there is no received data packet, so you can avoid the errata condition.</p> <p>Refer to following pseudo-code.</p> <pre style="background-color: black; color: yellow; padding: 10px;"> /* Change sendto() function */ Function sendto() { ... While (RXDV == '1') ; SEND command; /* Complete Sending */ } </pre>
Recommendation	<p>In case of W5100,</p> <p>We don't have solution but we can give a recommendation.</p> <p>After complete a transmission process, check whether Sn_TX_RD and Sn_TX_WR have same values or not. If both values are still different, close the socket and reset by force.</p> <pre style="background-color: black; color: yellow; padding: 10px;"> /* Change sendto() function */ Function sendto() { ... /* Complete Sending */ /* wait until Sn_TX_WR and Sn_TX_RD are same */ While (Sn_TX_WR != Sn_TX_RD) { wait some time; loop_cnt++; if (loop_cnt > CONST_BLOCK_CNT) goto RESET } } </pre>

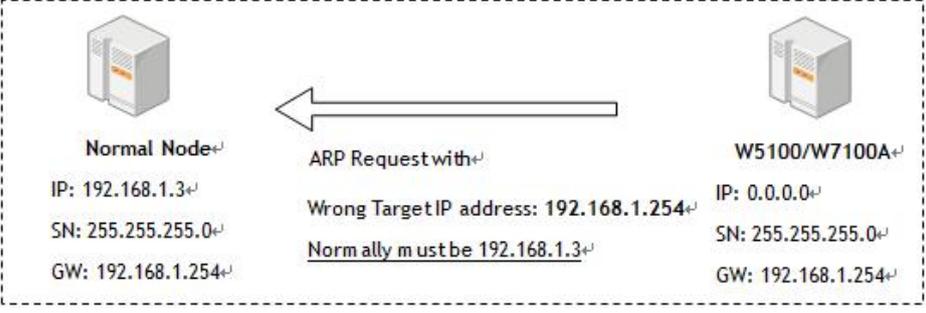
Erratum 3	
Phenomenon	Assuming that the IP address of W5100 is “0.0.0.0” and the gateway, subnet mask is valid (not “0.0.0.0”), the W5100 set the target IP address of ARP request to the gateway IP address not the target node IP address when sends ARP request to another node. So the peer node cannot receive the ARP request from the W5100.
Condition	<div style="border: 1px dashed black; padding: 10px; text-align: center;">

<p>Normal Node IP: 192.168.1.3 SN: 255.255.255.0 GW: 192.168.1.254</p> <p>W5100/W7100A+ IP: 0.0.0.0 SN: 255.255.255.0 GW: 192.168.1.254</p> </div> <p>The W5100 miss calculates the sub-network location when sends the ARP request if its own IP address is “0.0.0.0”. In the same condition, even if the gateway IP address is “0.0.0.0”, the W5100 sends ARP request to “0.0.0.0” IP address because the W5100 sends ARP request to the gateway.</p>
Solution	The reason of this erratum3 is same as erratum2 so the solution is also same with erratum2. Please refer to the solution of erratum2.
